# Bell Housing

## Cast Steel, Green Sand Casting

A steel bell housing casting of overall size 600 mm x 550 mm x 150 mm weighing 55 kg was produced by sand casting process. This item suffered from cracks in the inside rim region, discovered after machining. Most of these castings could be repaired, though at additional cost.

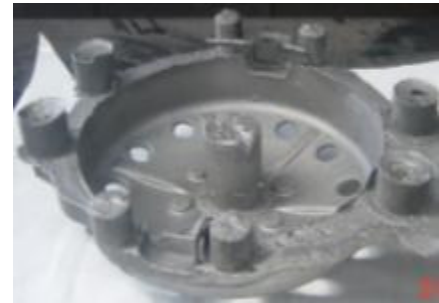
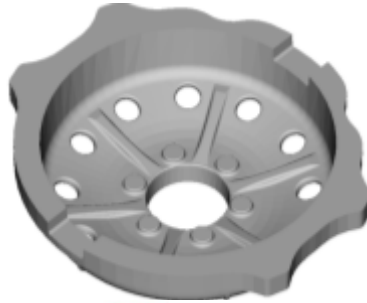
Thickness analysis of the part in a cross section through the ear portion of the rim clearly shows a L-junction with a rapid change of thickness, a cause for stress concentration.
